Protein electrophoresis and troubleshooting

Alaa El-Din Hamid Sayed,

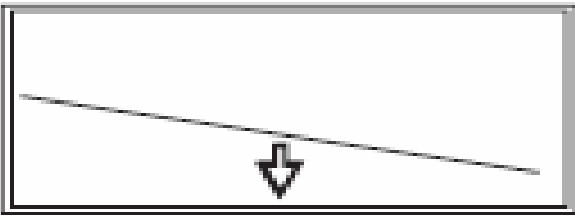
Symptom	Cause	Remedy
<p>The front is crooked.</p>

<p>Irregular electrical contact.</p> <p>The buffer concentration in the electrode strips is irregular because they were not held straight when they were soaked or placed on the gel.</p> <p>The casting mold was not levelled when the disk or gradient gels were cast.</p>	<p>See above.</p> <p>Make sure that the electrode wicks are always held straight.</p> <p>Set the mold level with a spirit-level.</p>
<p>The front is curved.</p>

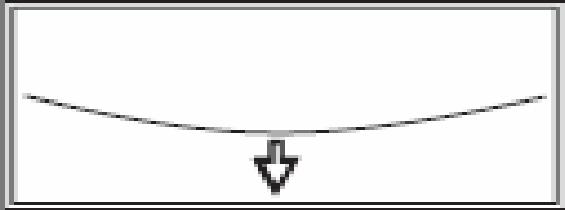
<p>The gel polymerized before the density gradient had settled or before the density discontinuity was finished.</p>	<p>Delay the onset of the polymerization: either by reducing the quantity of APS and/or by cooling the casting cassette in the refrigerator.</p>
<p>The front is uneven or wavy.</p>	<p>The gel surface has dried out in places under the holes in the lid.</p>	<p>Only for Multiphor I: Place a glass plate or electrode holder over the electrode wicks and the gel.</p>
